Chicora Research Contribution 552

Preservation Assessment of Tolson's Chapel Cemetery, Sharpsburg, Maryland

Prepared By:
Michael Trinkley, Ph.D.
and
Debi Hacker

May 1, 2013

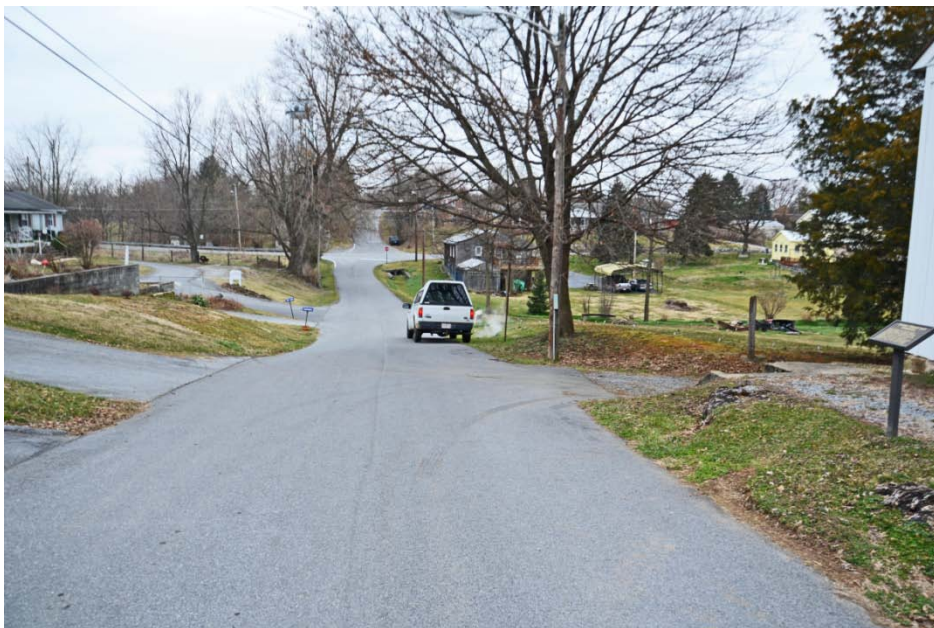
This is an issue at the chapel since the only parking for visitors is on the grassed area immediately in front of the double gates to the east of the chapel. Immediately in front of the chapel there is a slight elevation, steps, and a tree stump. Alternative parking is presumably available in the alley to the west, although it consists of only one gravel travel lane, about 8 feet in width. Parking here, at least on a regular basis, would hinder residential use of the alley for house access.

Figure 17. High Street with Tolson's Chapel to the right looking west. The alley along the west side of the cemetery is shown leading off High Street. Note also the slope from the road up to the chapel building.

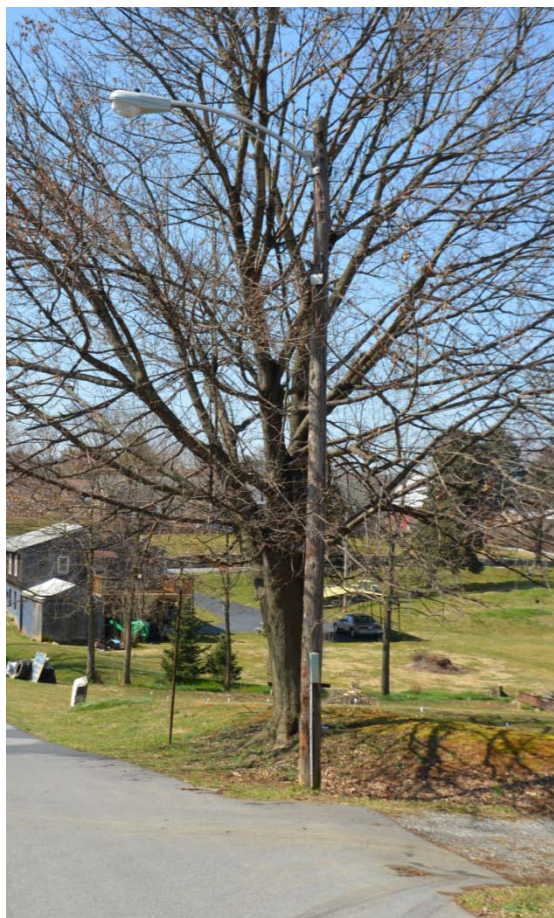
Figure 23. Cobra head luminaire adjacent to the chapel.

There is a standard single arm steel bracket with cobra head luminaire mounted on a utility pole southwest of the chapel, adjacent to the alleyway. We do not recommend that any additional lighting be installed.

Lighting is adequate and we do not recommend any additions.

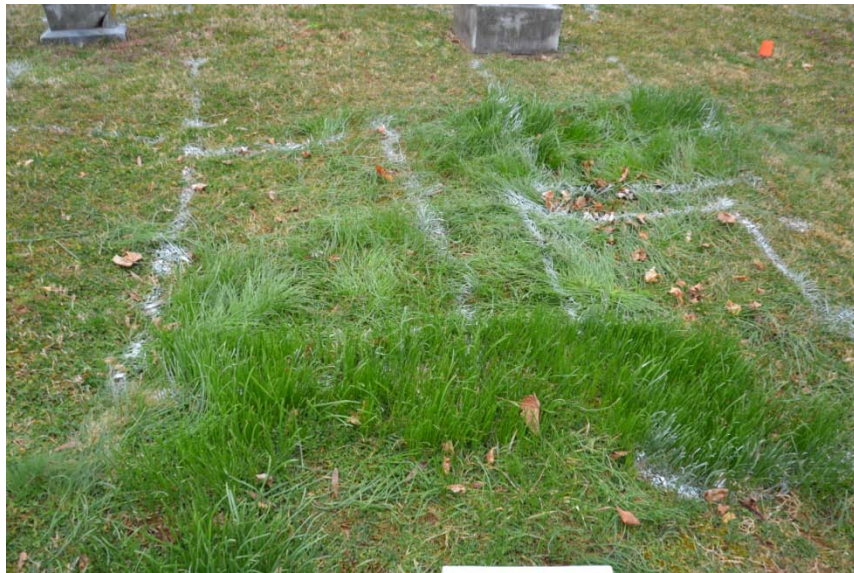
In several areas there are very large stands of wild garlic (*Allium vineale*). A good introduction to this weed is <http://www.clemson.edu/extension/hgic/pests/pdf/hgic2311.pdf> (Figure 26).

Figure 26. Weeds in the cemetery showing a large stand of wild garlic. While the turf is still dormant, the weeds already suggest the need to mow.

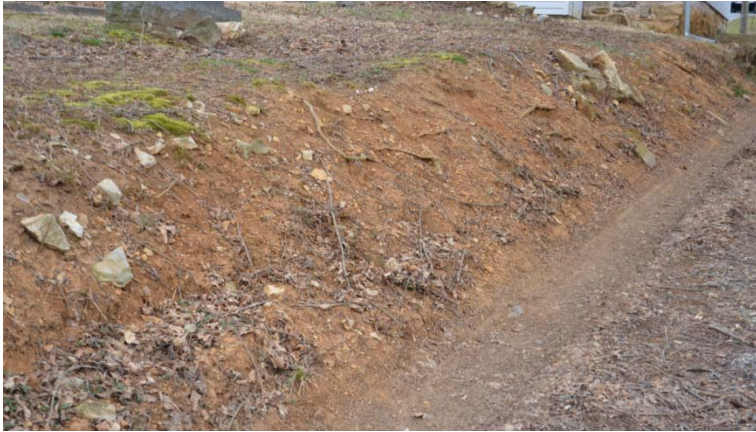
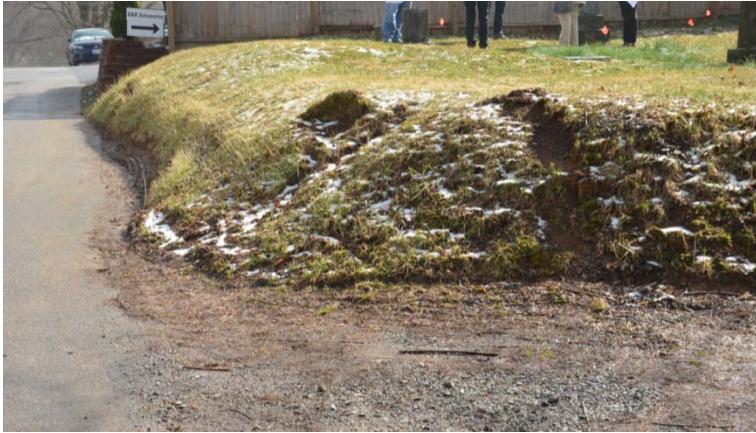
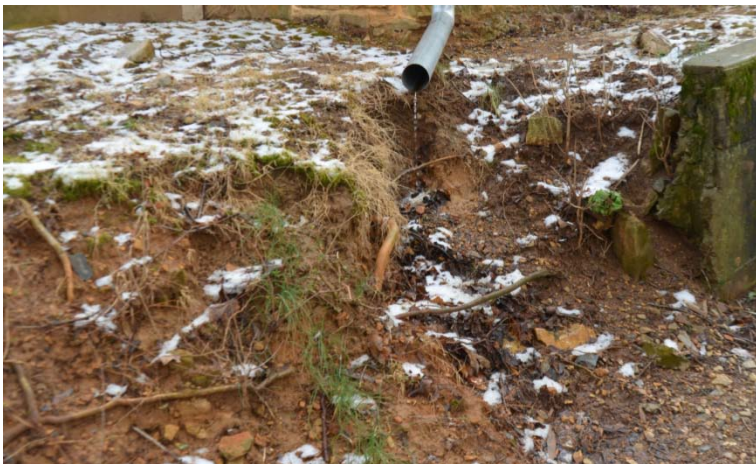
Figure 28. Erosion at the cemetery. The upper photo shows erosion along the west bank. The middle photo shows erosion from using the northwest corner as a bicycle ramp. The bottom photo shows erosion from a church building gutter draining directly onto the slope.

As Figure 28 reveals, there is erosion along the bank at the western and northern edges of the cemetery. Causes include shade from nearby trees, inappropriate drainage from the new roof, and the use of the slope as a bicycle ramp.

To minimize the use of the northern cemetery slope as a bicycle ramp we recommend the installation of hand placed rip-rap softened with the planting of a hardy, low maintenance ground cover such as liriop. This is likely more effective, easier to integrate into the historic landscape, and will require less maintenance than a fence.

Terracing would be required, using a technique called is reed-trench terracing. A series of wooden barriers, or checkboards are staked out along the contours, with a trench dug behind (upslope). This trench is then filled with reed grass (*Phragmites communis*) and then covered with good topsoil (Figure 29). The series of terraces tends to arrest downward movement of soil and also provides areas for vegetation to become established. The reeds serve important functions in this process — preventing the soil from drifting under the checkboards, reducing gullying, serving as an underground reservoir of water, and providing nutrients. Plantings on these terraces tend to establish very deep root systems. The wood checkboards should be made of un-treated lumber and may either be left in place to rot, or may be removed when the vegetation is stable.

Rip-rap is even possible on very steep slopes by extending the toe of the rock outward (see Figure 30). The cost is likely about \$25 to \$50 per square yard. If rip-rap is placed only where needed, we estimate that approximately 100 square yards will be required. If installed properly, rip-rap does not typically require much maintenance, although it should be periodically inspected for evidence of failure.

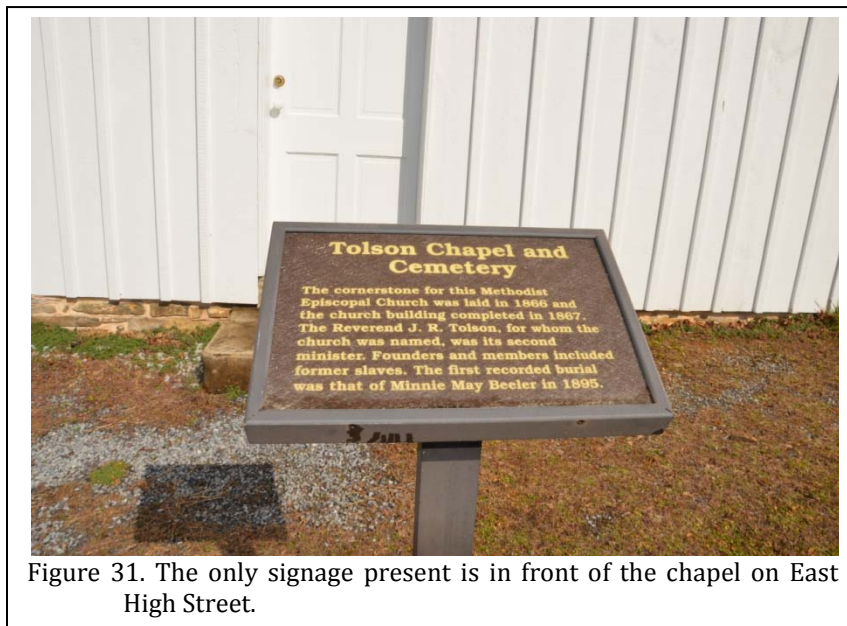
Regulatory signage specifies laws, regulations, or expected standards of behavior. There is no regulatory signage at the cemetery and this should receive a very high priority. We recommend the following items be included in the regulations affecting the cemetery:

Figure 31. The only signage present is in front of the chapel on East High Street.

The cemetery requires regulatory signage and we recommend placement at the entrance gates as well as smaller or abbreviated signs (perhaps combined with identification signage) along the west and north banks.

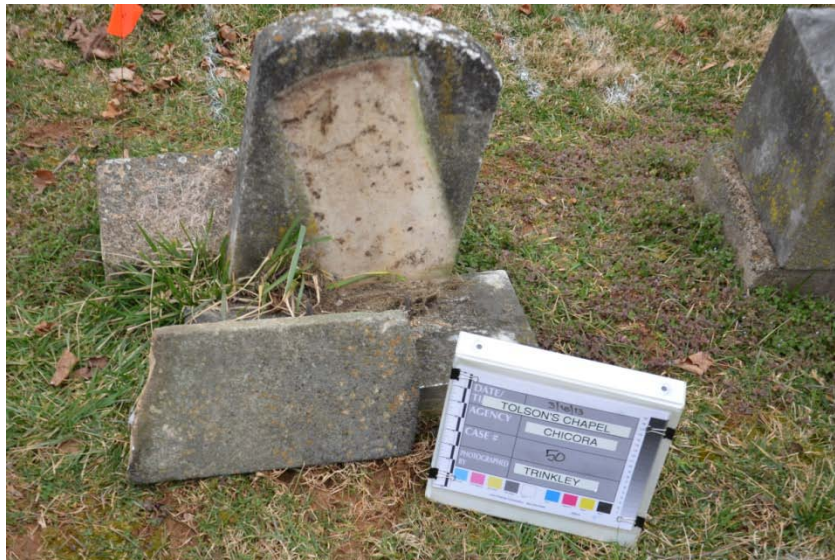
Lost, orphan, or misplaced stones appear to be rare at Tolson's Chapel Cemetery and only one was observed (Figure 32). These are stones that have been removed from the original grave and deposited elsewhere in the cemetery. Stones move for a variety of reasons, but the most common is an effort by maintenance crews to place them out of the way.

Figure 32. Orphan footstone in foreground showing the stain on another headstone where it had been leaning for a number of years.

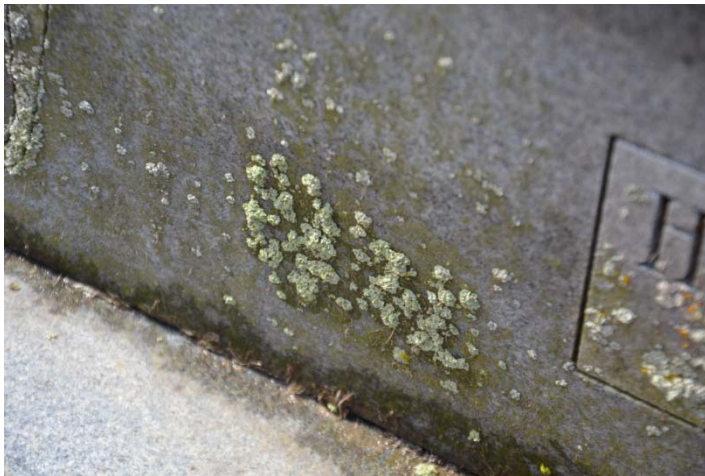
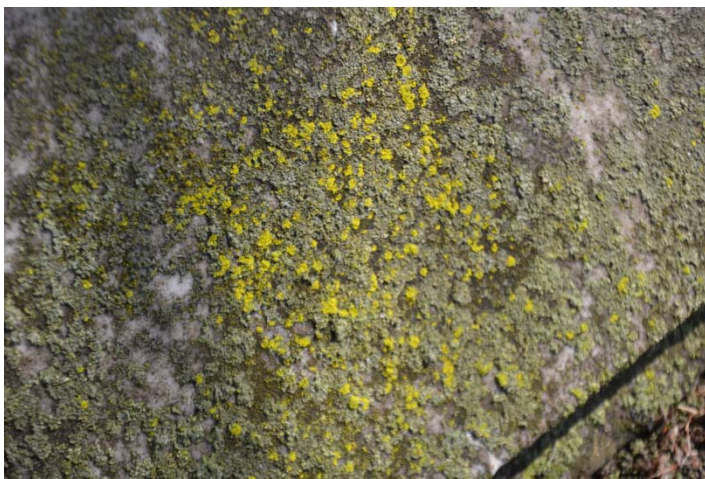
Figure 35. Close up photographs of two stones exhibiting dense biological growth.

A suitable biocide for cleaning stones is

D/2 Biological Solution (<http://d2bio.com/>) available from a variety of conservation suppliers. Stones should always be prewetted prior to application of D/2 and after dwelling for a few minutes followed by gentle scrubbing, should be flushed from the stone.

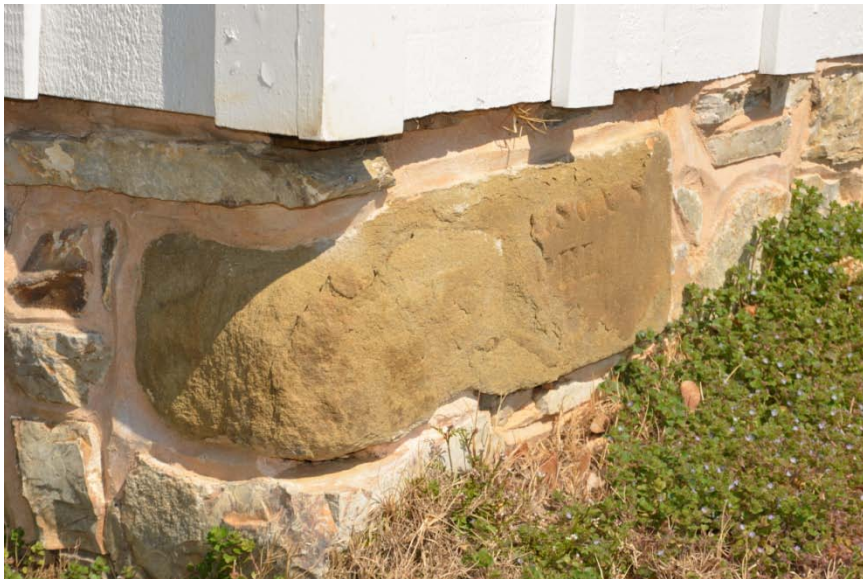
While not specifically included in this project, it may be useful to briefly mention the badly deteriorated condition of the Tolson's Chapel cornerstone (Figure 36).

Figure 36. Cornerstone showing extensive spalling of the sandstone with the loss of most of the original carving.

All repairs in the Cemetery should be conducted by trained conservators who subscribe to the Code of Ethics and Guidelines for Practice of the American Institute for Conservation of Historic and Artistic Works (AIC). This should be the minimum level of competency required by FOTC on all projects.

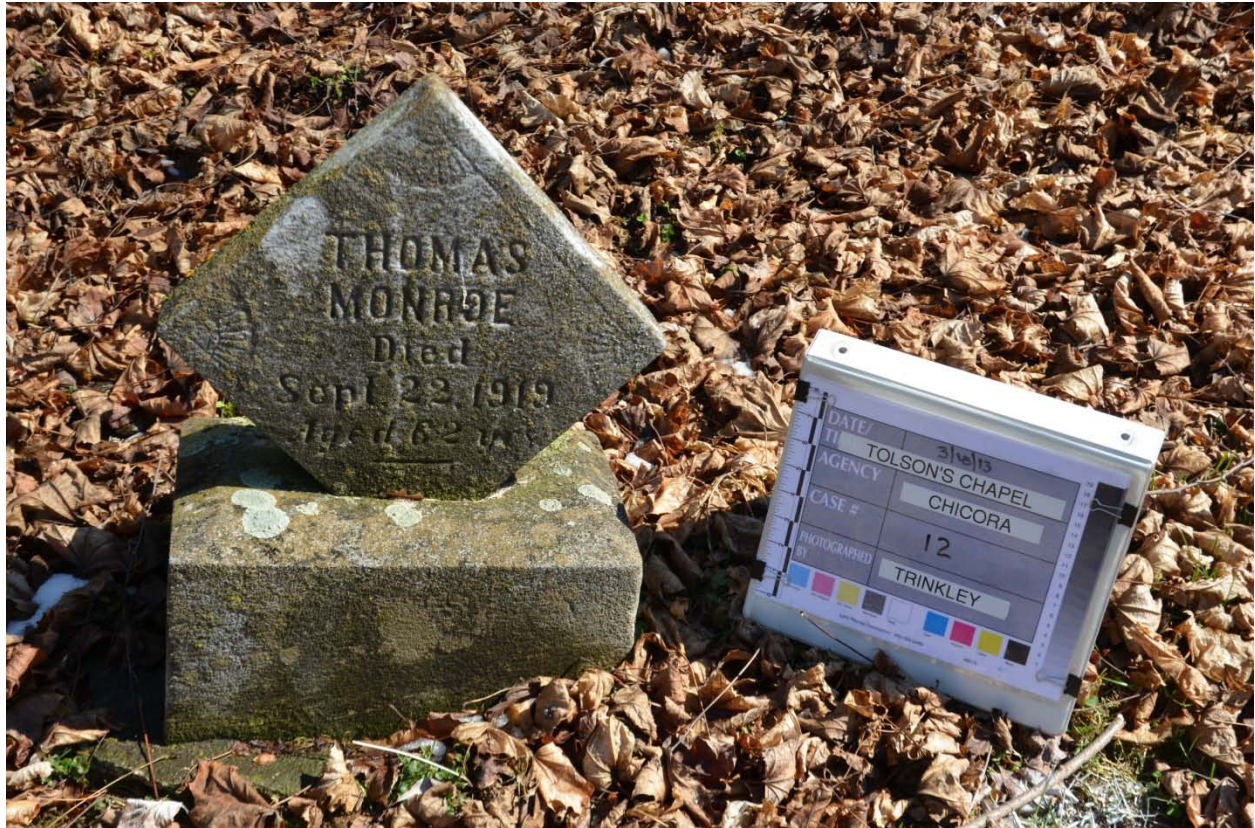
Position: ☐ fallen ☒ tilted ☐ unstable ☐ unattached/loose ☐ missing

Soiling: ☒ biological ☐ staining ☐ efflorescence ☐ other:

Position: ☒ reset/level in ground ☐ reset/level to existing base ☐ construct new base ☐ resquare
☐ possible new base required ☐ stabilize foundation ☐ reset with 1:2.5 NHL 3.5 mix ☐ reset with compound
☐ other:

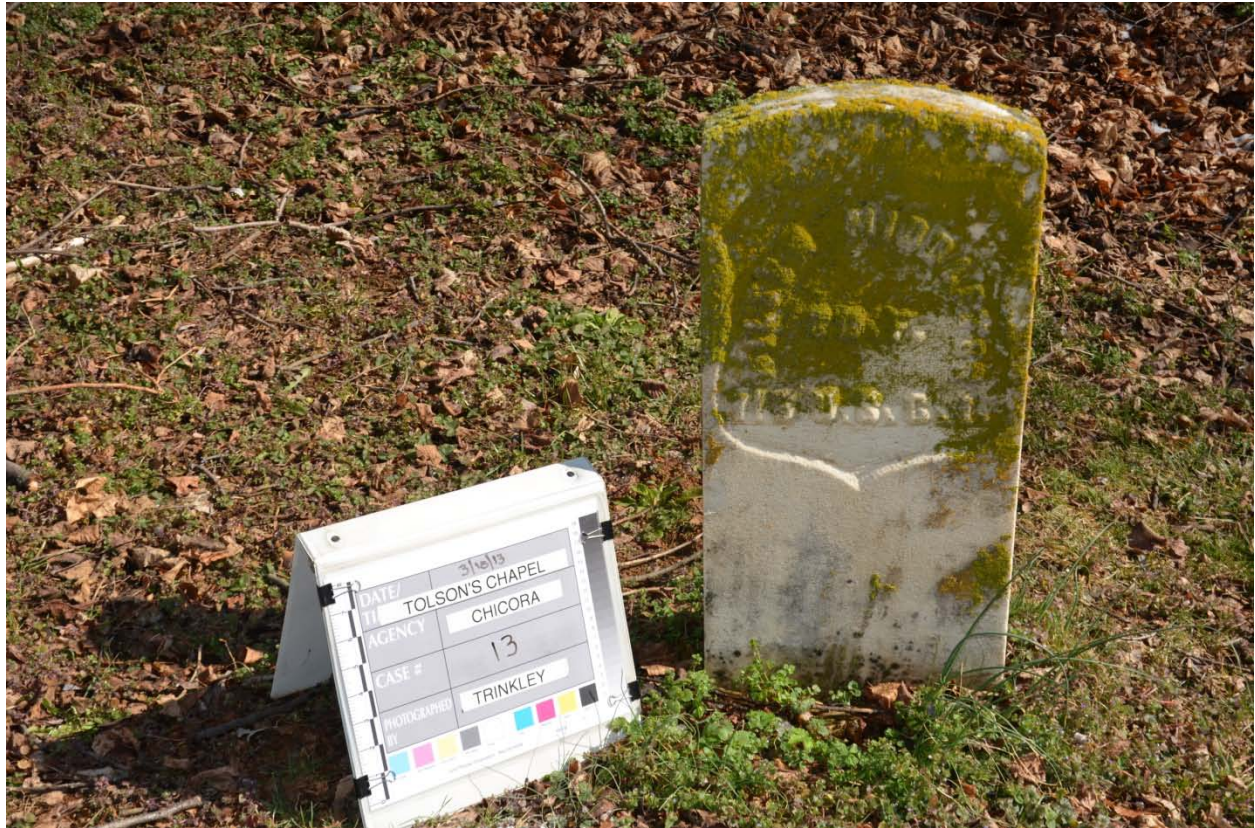
Position: ☐ fallen ☒ tilted ☐ unstable ☐ unattached/loose ☐ missing

Failed/Old Treatments: ☐ metal ☐ adhesives/coatings ☐ mortar ☒ other: set in OPC

Soiling: ☒ biological ☒ staining ☐ efflorescence ☐ other:

Position: ☒ reset/level in ground ☐ reset/level to existing base ☐ construct new base ☐ resquare
☐ possible new base required ☐ stabilize foundation ☐ reset with 1:2.5 NHL 3.5 mix ☐ reset with compound
☐ other:

Treatment: ☐ core drill ☐ drill and pin ☐ simple adhesive repair ☐ injection grout ☐ replace bricks
☐ mortar ☐ repoint ☐ infill ☒ other: remove OPC

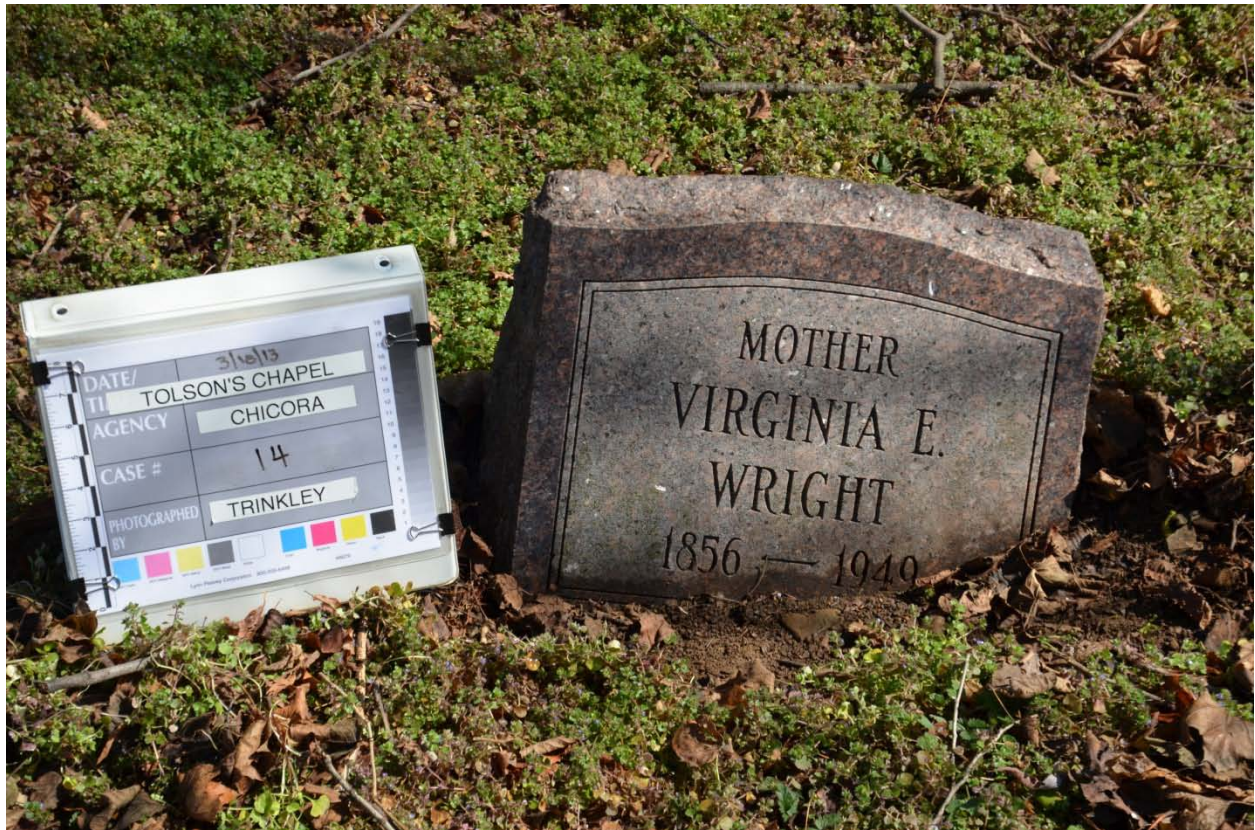
Condition: tilted,
biologicals, mower
damage

Position: ☐ fallen ☒ tilted ☐ unstable ☐ unattached/loose ☐ missing

Deterioration: ☐ broken ☐ cracked ☐ losses ☐ flaking/sugaring ☒ ferrous pins ☐ brass pins
☐ delamination/detachment ☐ spalling ☐ missing fragments ☐ other:

Failed/Old Treatments: ☐ metal ☐ adhesives/coatings ☒ mortar ☐ other:

Position: ☒ reset/level in ground ☐ reset/level to existing base ☐ construct new base ☐ resquare
☐ possible new base required ☐ stabilize foundation ☒ reset with 1:2.5 NHL 3.5 mix ☐ reset with compound
☒ other: remove or bury OPC base

Treatment: ☒ core drill ☐ drill and pin ☐ simple adhesive repair ☐ injection grout ☐ replace bricks
☐ mortar ☐ repoint ☐ infill ☒ other: replace ferrous pin with fiberglass pin

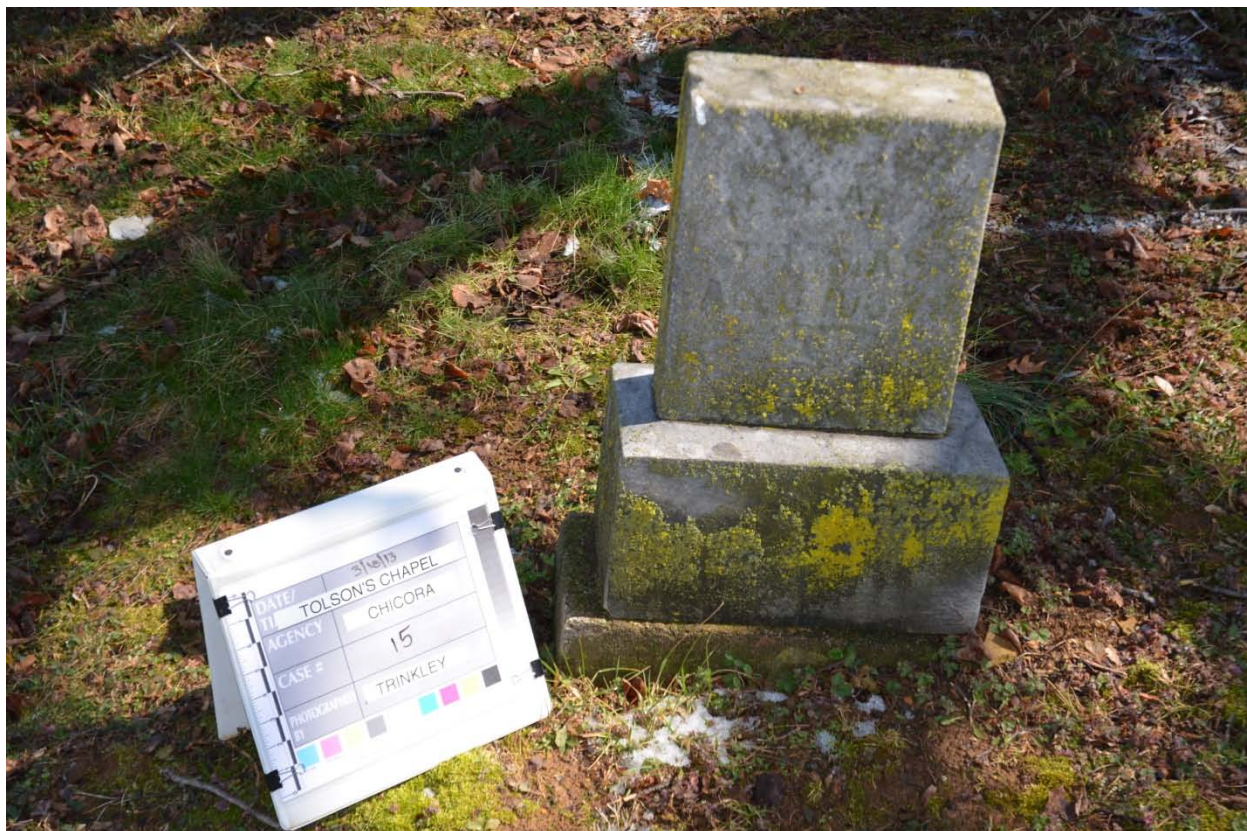
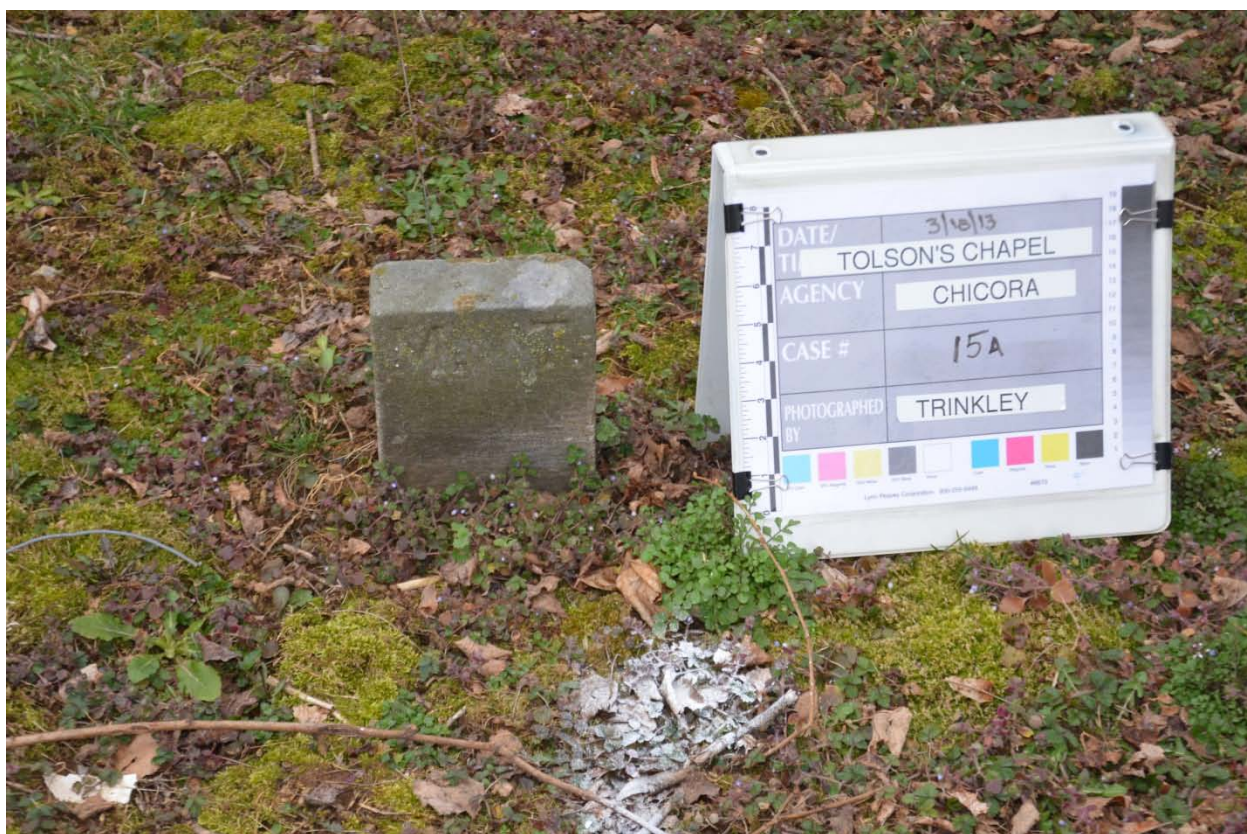
Position: ☐ fallen ☐ tilted ☒ unstable ☐ unattached/loose ☐ missing

Deterioration: ☐ broken ☐ cracked ☐ losses ☐ flaking/sugaring ☒ ferrous pins ☐ brass pins
☐ delamination/detachment ☐ spalling ☐ missing fragments ☐ other:

Failed/Old Treatments: ☐ metal ☐ adhesives/coatings ☐ mortar ☒ other: set in OPC

Position: ☒ reset/level in ground ☐ reset/level to existing base ☐ construct new base ☐ resquare
☐ possible new base required ☐ stabilize foundation ☒ reset with 1:2.5 NHL 3.5 mix ☐ reset with compound
☐ other:

Treatment: ☒ core drill ☒ drill and pin ☐ simple adhesive repair ☐ injection grout ☐ replace bricks
☐ mortar ☐ repoint ☐ infill ☒ other: remove OPC; replace ferrous pin with fiberglass pin

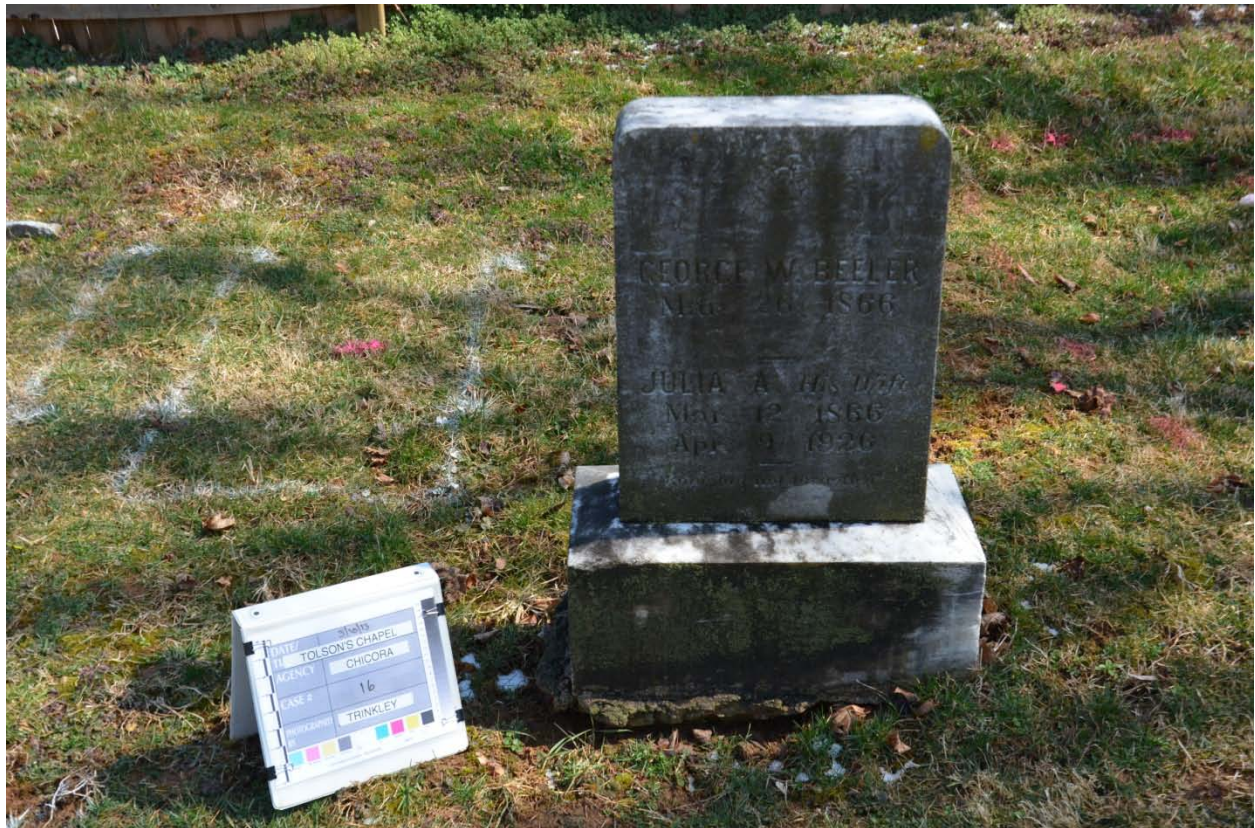
Condition: losses,
extensive mower damage

Position: ☐ fallen ☐ tilted ☒ unstable ☐ unattached/loose ☐ missing

Deterioration: ☐ broken ☐ cracked ☐ losses ☐ flaking/sugaring ☒ ferrous pins ☐ brass pins
☐ delamination/detachment ☐ spalling ☐ missing fragments ☒ other: set in/on OPC

Position: ☒ reset/level in ground ☐ reset/level to existing base ☐ construct new base ☐ resquare
☐ possible new base required ☐ stabilize foundation ☒ reset with 1:2.5 NHL 3.5 mix ☐ reset with compound
☐ other:

Treatment: ☒ core drill ☒ drill and pin ☐ simple adhesive repair ☐ injection grout ☐ replace bricks
☐ mortar ☐ repoint ☐ infill ☒ other: remove OPC; replace ferrous pin with fiberglass pin

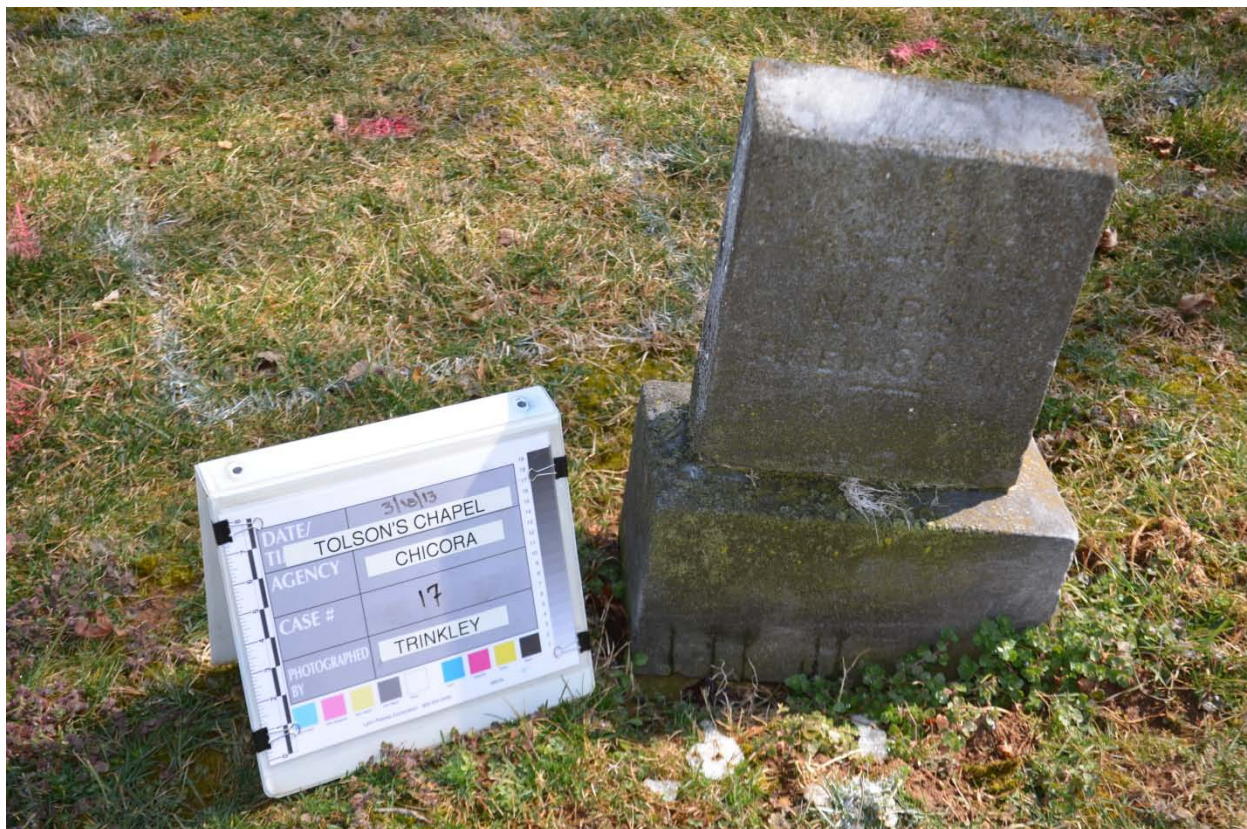
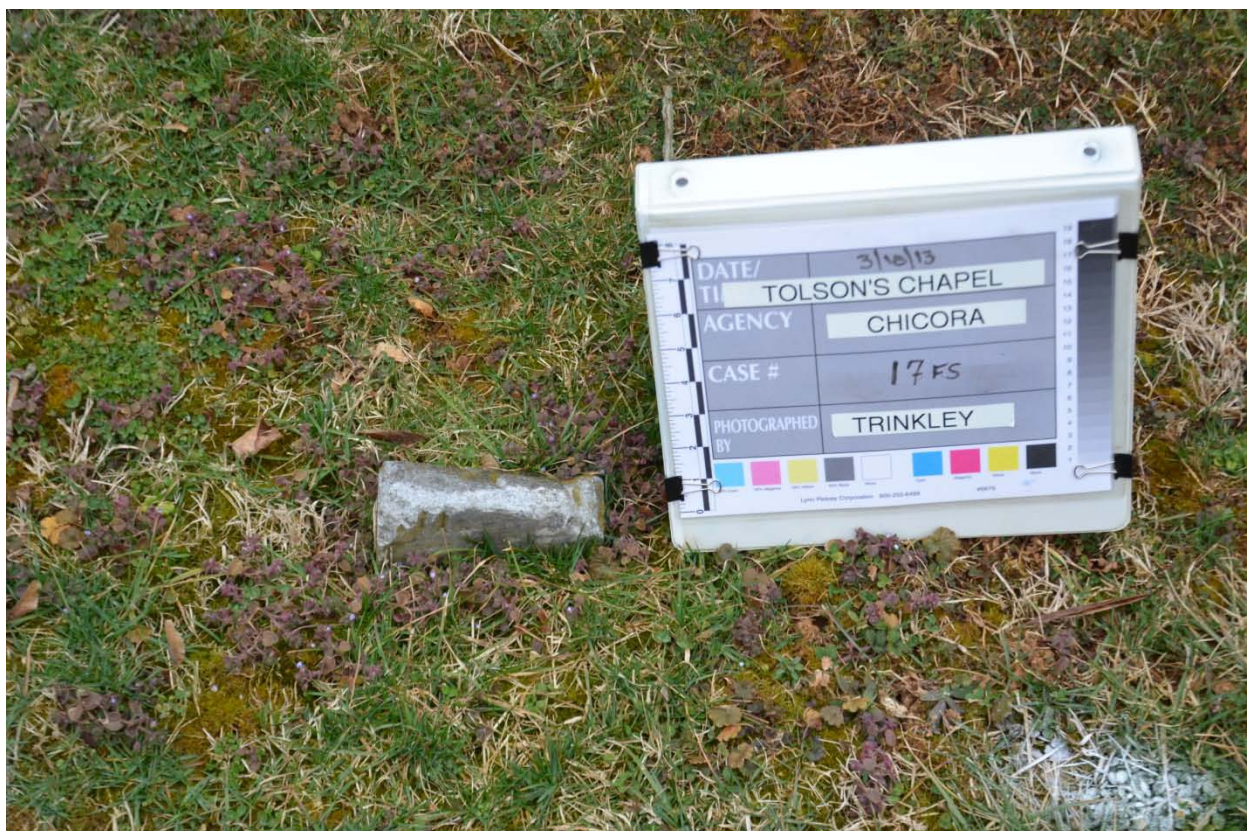
Condition: tilted, mower
damage, biologicals

Position: ☐ fallen ☐ tilted ☒ unstable ☐ unattached/loose ☐ missing

Deterioration: ☐ broken ☐ cracked ☐ losses ☒ flaking/sugaring ☐ ferrous pins ☐ brass pins
☐ delamination/detachment ☐ spalling ☐ missing fragments ☐ other:

Failed/Old Treatments: ☐ metal ☐ adhesives/coatings ☐ mortar ☒ other: set on/in OPC

Position: ☒ reset/level in ground ☐ reset/level to existing base ☐ construct new base ☐ resquare
☐ possible new base required ☐ stabilize foundation ☒ reset with 1:2.5 NHL 3.5 mix ☐ reset with compound
☐ other:

Treatment: ☐ core drill ☒ drill and pin ☐ simple adhesive repair ☐ injection grout ☐ replace bricks
☐ mortar ☐ repoint ☐ infill ☒ other: remove OPC

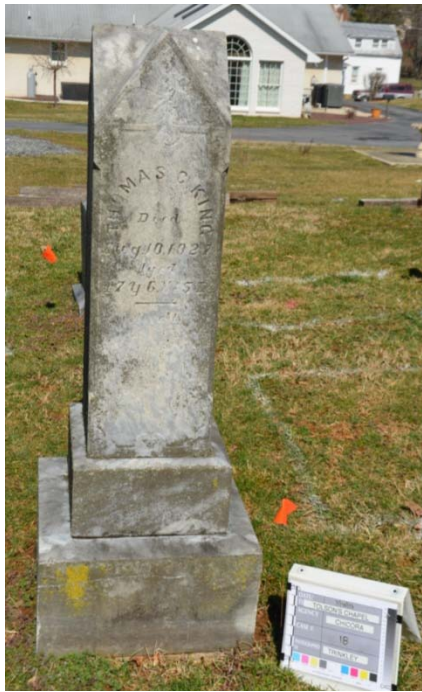
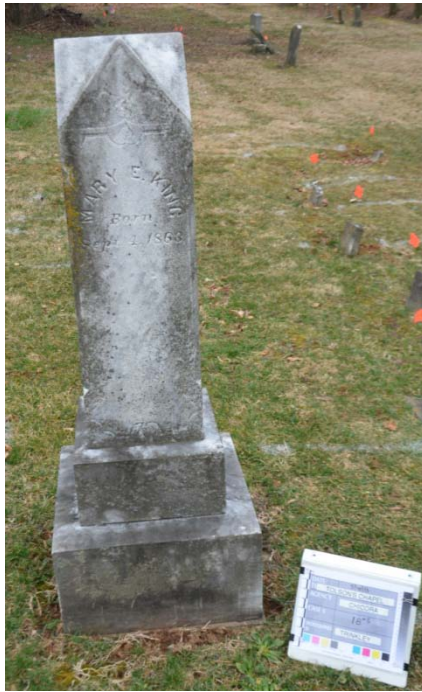
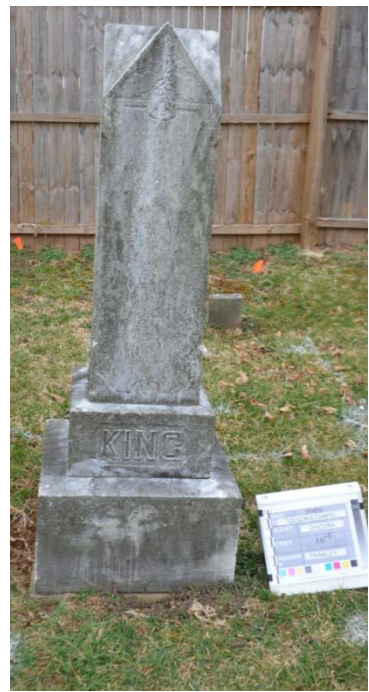
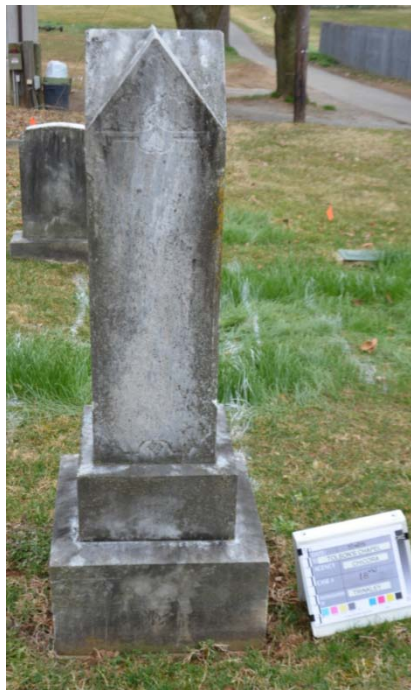
Condition: tilted, mower damage, biologicals

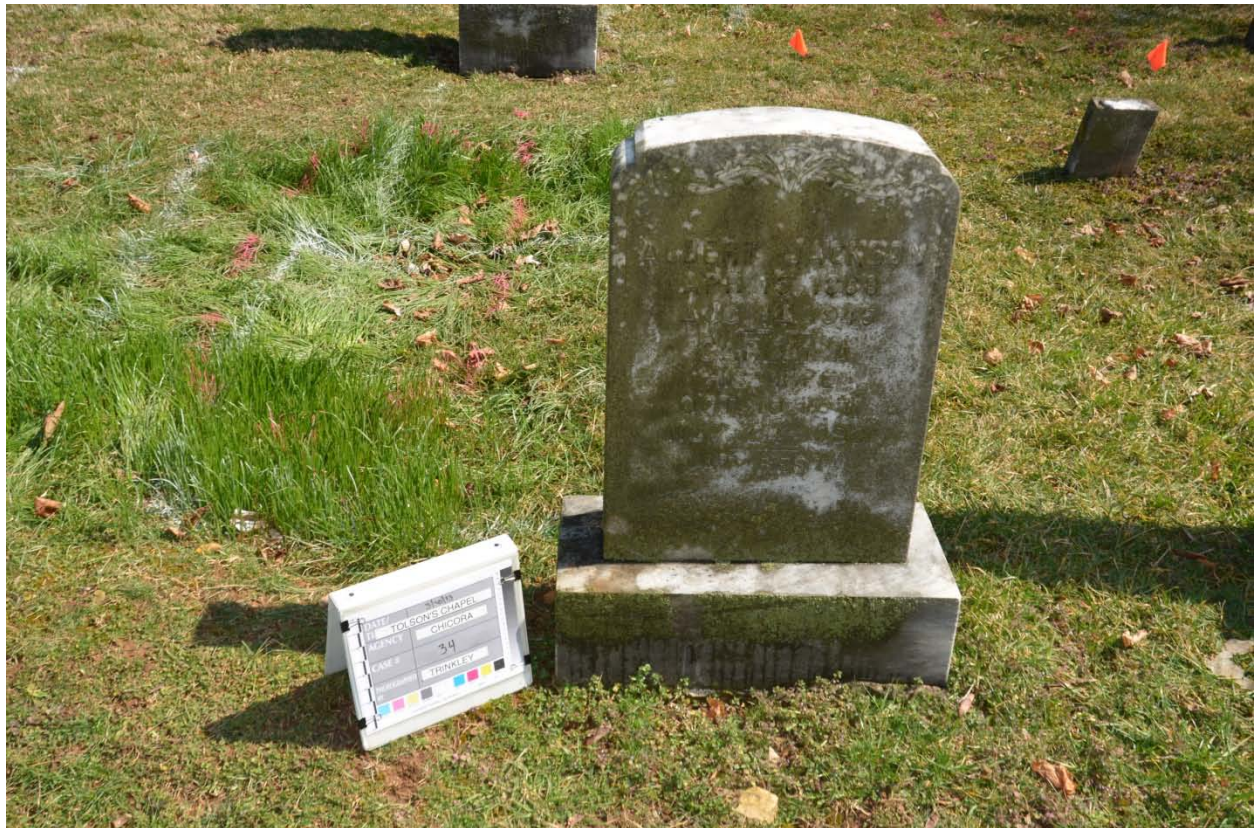
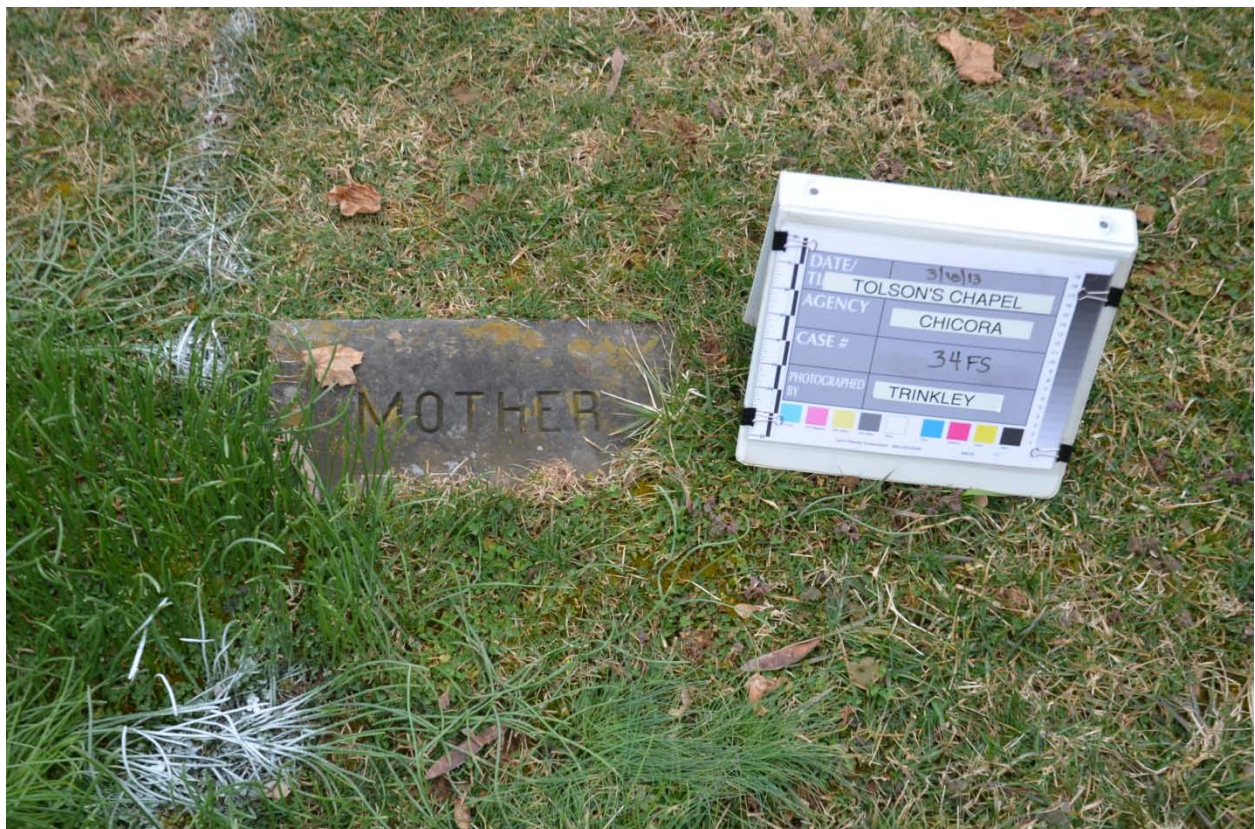
Existing Condition

Position: ☐ fallen ☐ tilted ☐ unstable ☐ unattached/loose ☐ missing

Legibility: ☐ sharp, tooling evident ☒ clear, but worn ☐ partially discernable ☐ not discernable

Deterioration: ☐ broken ☐ cracked ☒ losses ☒ flaking/sugaring ☐ ferrous pins ☐ brass pins
☐ delamination/detachment ☐ spalling ☐ missing fragments ☐ other:

Soiling: ☒ biological ☐ staining ☐ efflorescence ☐ other:

Position: ☐ reset/level in ground ☐ reset/level to existing base ☐ construct new base ☐ resquare
☐ possible new base required ☐ stabilize foundation ☐ reset with 1:2.5 NHL 3.5 mix ☐ reset with compound
☒ other: reset footstone

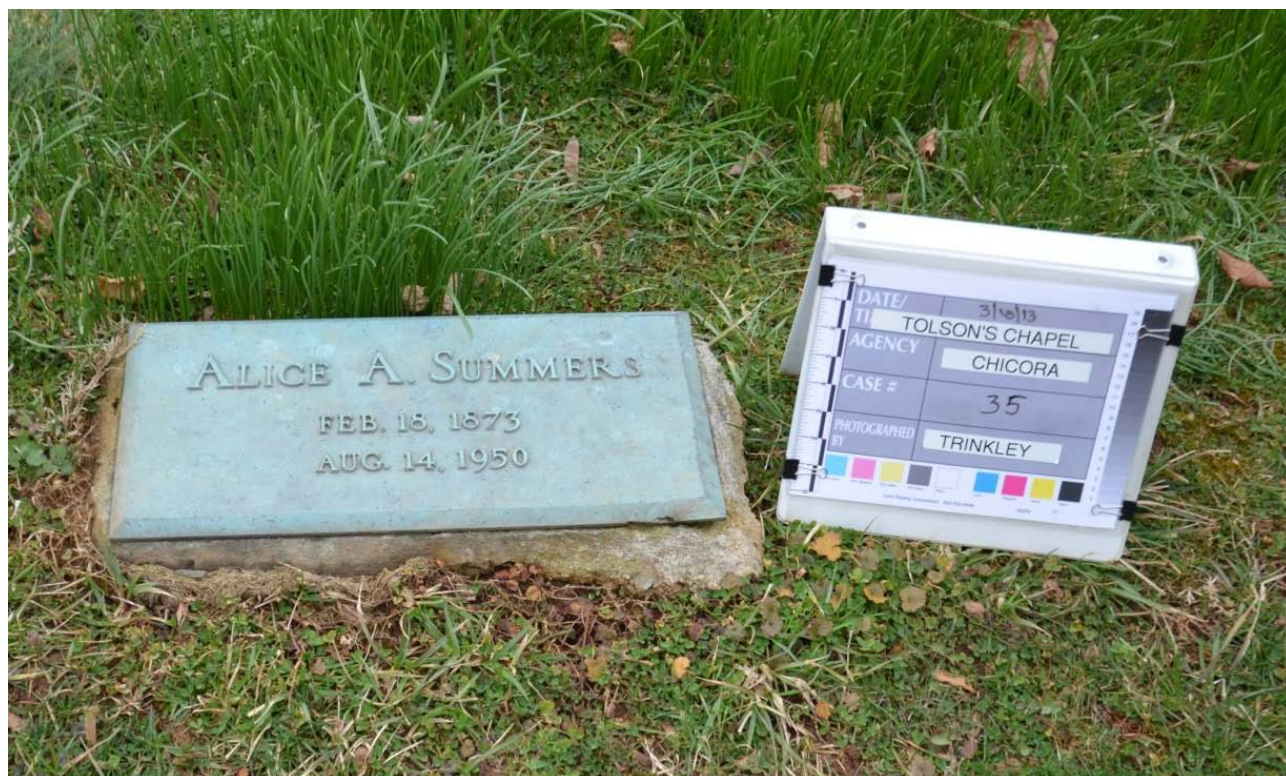
Position: ☐ fallen ☐ tilted ☐ unstable ☒ unattached/loose ☐ missing

Legibility: ☒ sharp, tooling evident ☐ clear, but worn ☐ partially discernable ☐ not discernable

Deterioration: ☐ broken ☐ cracked ☐ losses ☐ flaking/sugaring ☐ ferrous pins ☐ brass pins
☐ delamination/detachment ☐ spalling ☐ missing fragments ☒ other: edge damage, prob. mower

Soiling: ☐ biological ☒ staining ☐ efflorescence ☐ other:

Position: ☐ reset/level in ground ☐ reset/level to existing base ☒ construct new base ☐ resquare
☐ possible new base required ☐ stabilize foundation ☐ reset with 1:2.5 NHL 3.5 mix ☐ reset with compound
☒ other: reset on new base to prevent theft

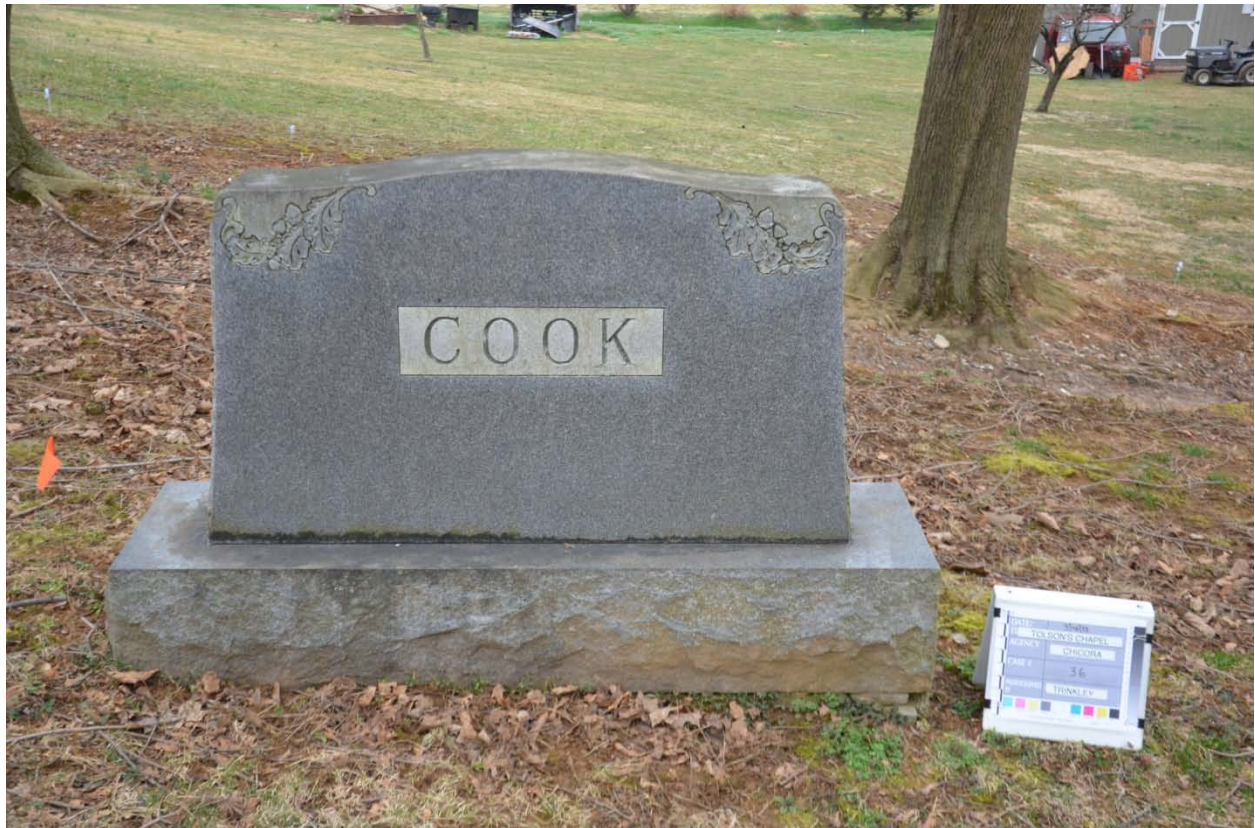
Position: ☐ fallen ☐ tilted ☒ unstable ☐ unattached/loose ☐ missing

Failed/Old Treatments: ☐ metal ☐ adhesives/coatings ☐ mortar ☒ other: setting compound

Soiling: ☒ biological ☐ staining ☐ efflorescence ☐ other:

Position: ☐ reset/level in ground ☐ reset/level to existing base ☐ construct new base ☐ resquare
☐ possible new base required ☐ stabilize foundation ☐ reset with 1:2.5 NHL 3.5 mix ☒ reset with compound
☐ other:

Treatment: ☐ core drill ☒ drill and pin ☐ simple adhesive repair ☐ injection grout ☐ replace bricks
☐ mortar ☐ repoint ☐ infill ☐ other:

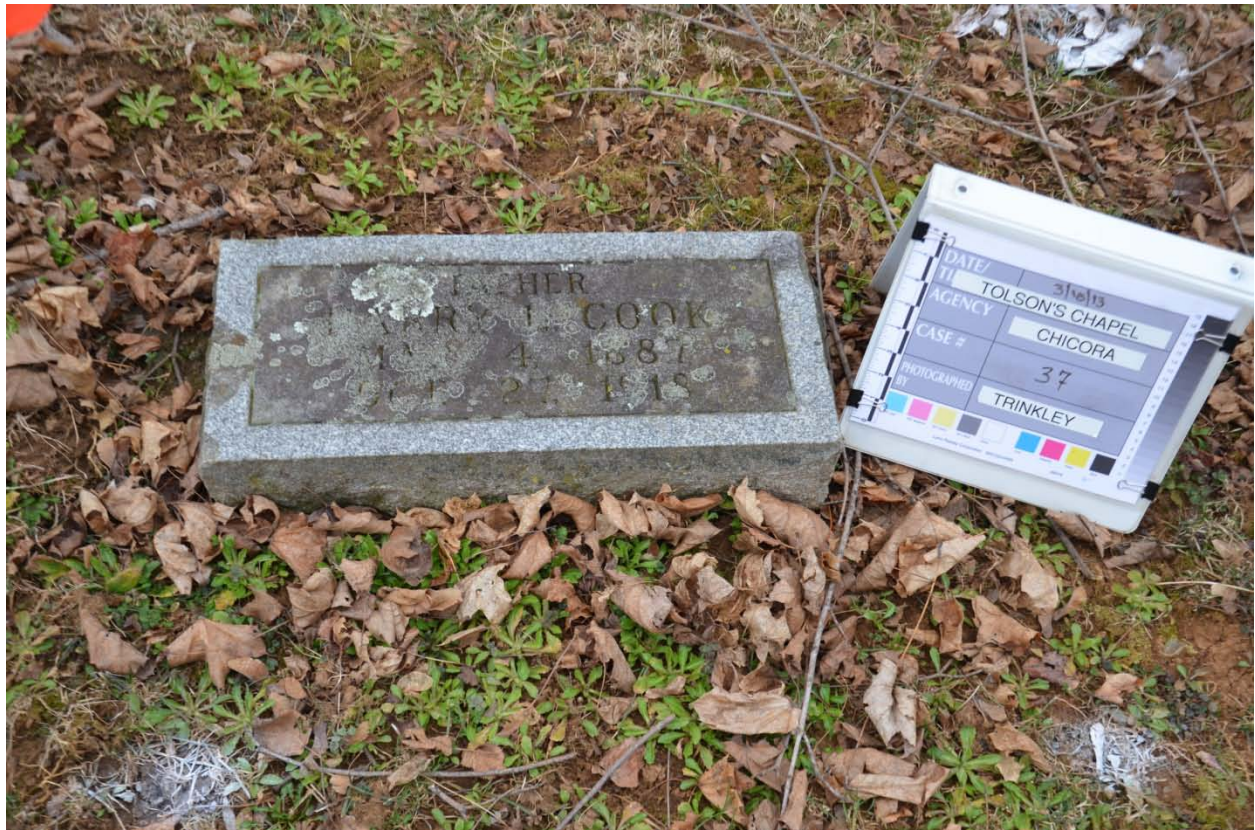
Deterioration: ☐ broken ☐ cracked ☒ losses ☐ flaking/sugaring ☐ ferrous pins ☐ brass pins
☐ delamination/detachment ☐ spalling ☐ missing fragments ☒ other: mower damage

Soiling: ☒ biological ☐ staining ☐ efflorescence ☐ other:
